# BATTERY POST ABUSE SAMPLES

## EXAMPLES OF 2 YEAR OLD BATTERY POSTS USED ONLY FOR AUTOMOTIVE STARTING PURPOSES

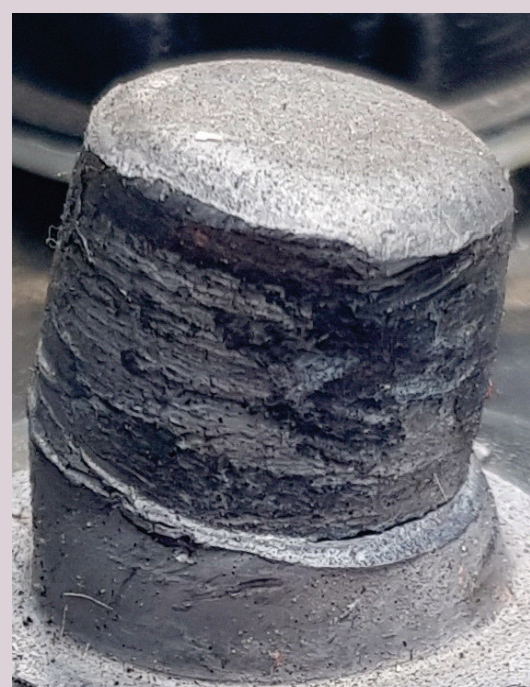
Post bend due to excessive force applied on post. This deformation may cause internal defects that can limit battery life

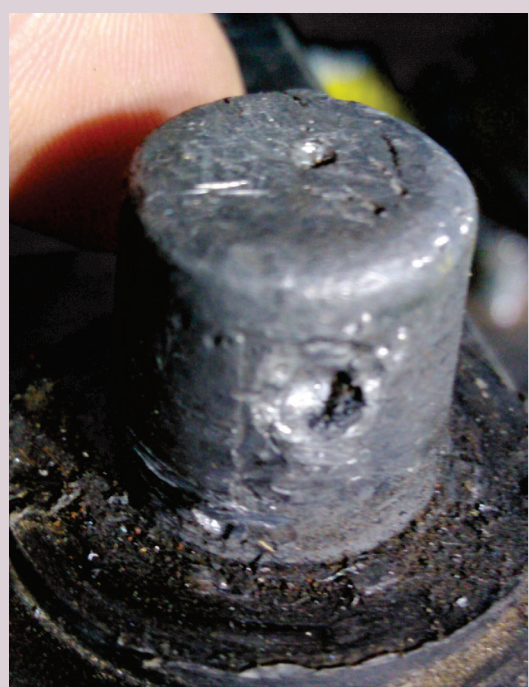
Hole drilled in post. This indicates that the battery was not only used for Automotive starting purposes and thus voids the conditions for warranty

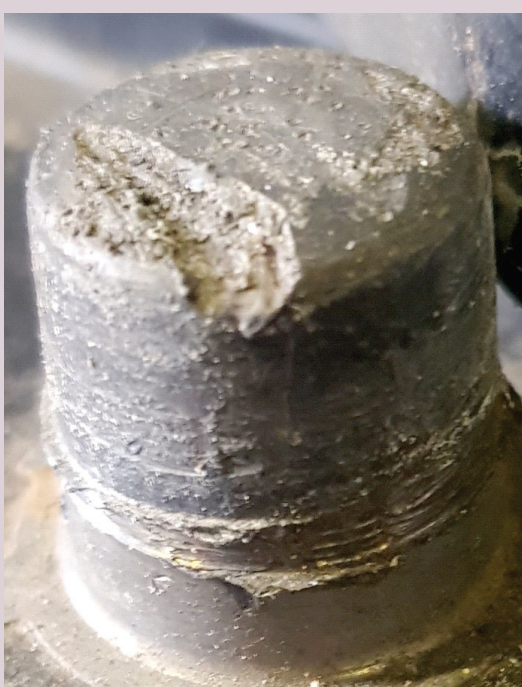
Led melted away due to sudden excessive current on top of post (Arc marks). This may cause high internal current that may reduce the lifetime of the battery

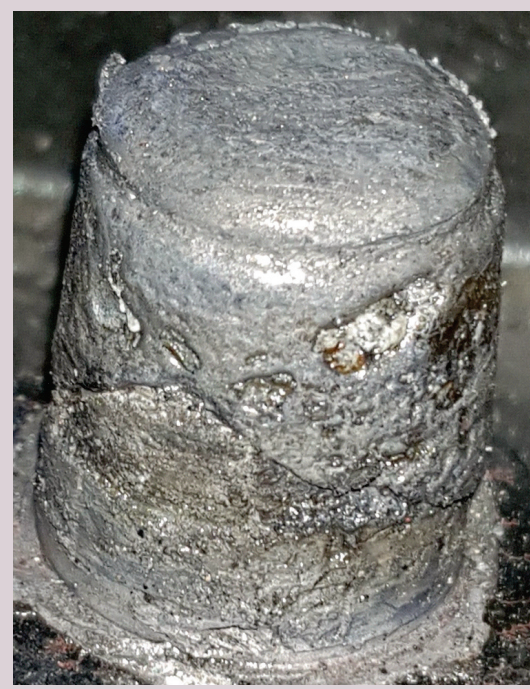
Lead re melted on top of post. This indicates rework done to the post that can cover a range of abuse

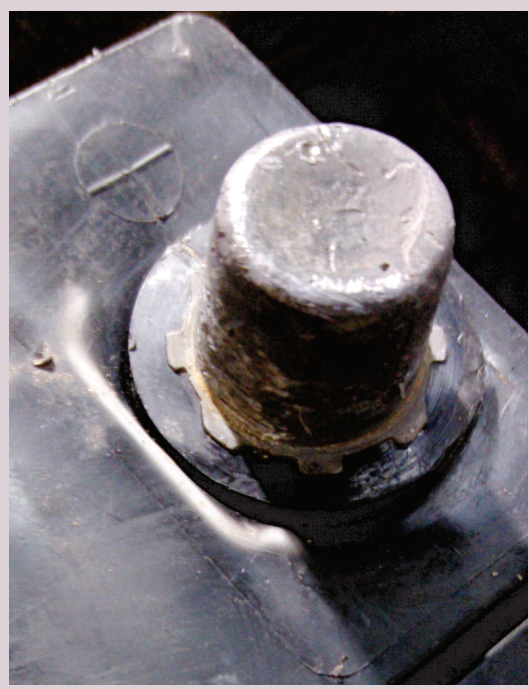
Excessive forces. It is visible from the battery casing that there has been excessive down force on the post that can damage the battery internally and reduce the lifespan of the battery

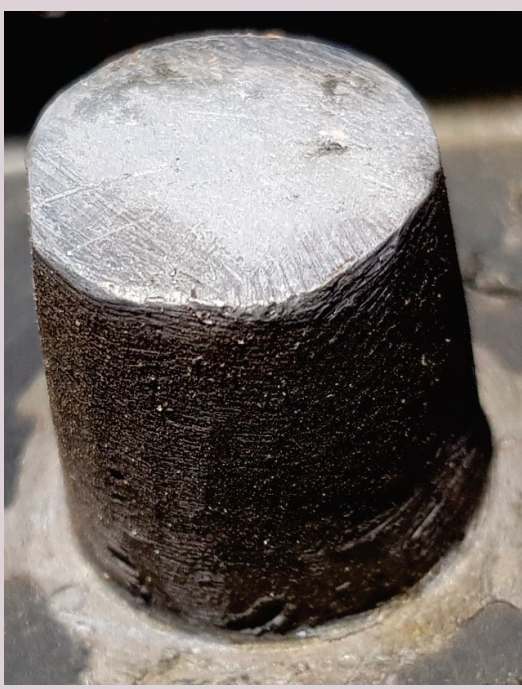
Reworked Post. The sharp edges and file/ sanding marks on the top and sides of the post indicate that the post was reworked and tampered with this voids the warranty

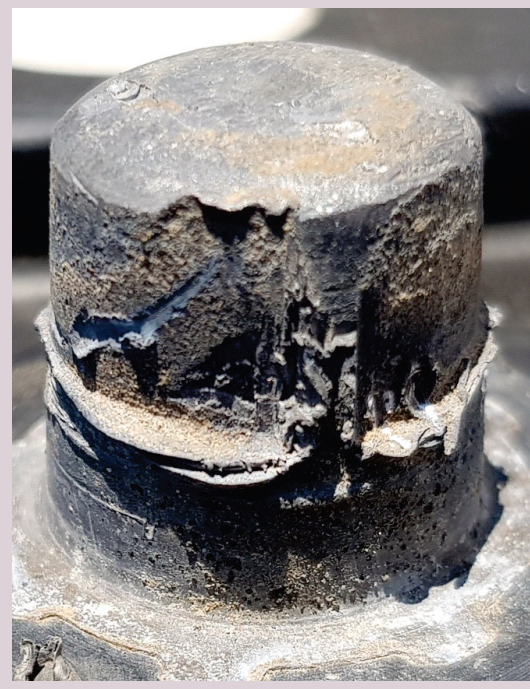
Battery terminal forced over post. These marks indicate that the battery terminal was smaller than the post and placed on the post with excessive down force creating the peeled lead marks and can cause internal damage that can reduce the battery lifetime

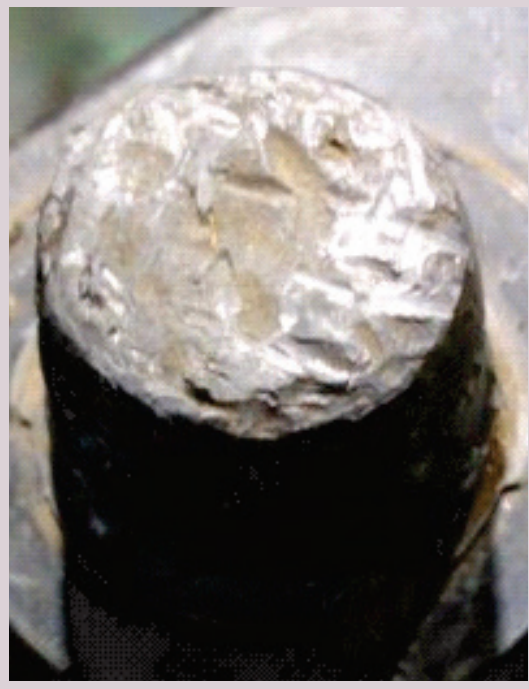
Indentations on the top of the post. This indicate "hammering" marks on the top of the post that can cause internal damage to the battery and reduce the lifespan of the battery

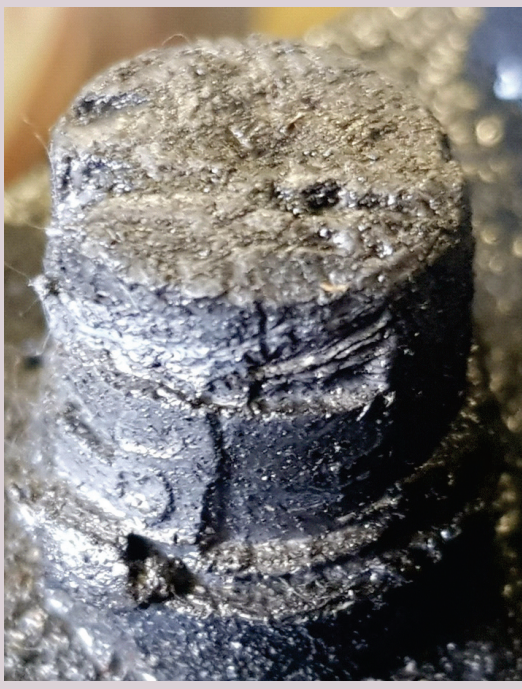
Re moulded post. This indicates that the post was tampered with and thus voids any warranty

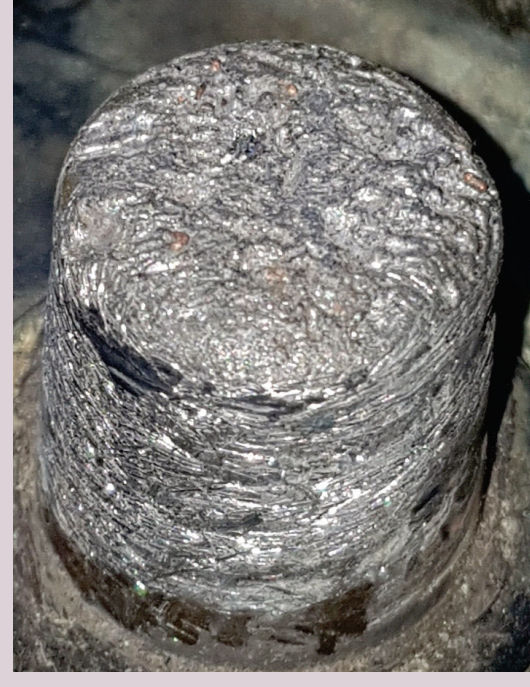
Marks on post. The marks are a clear indication that the battery was not only used for automotive starting purposes and thus voids any warranty

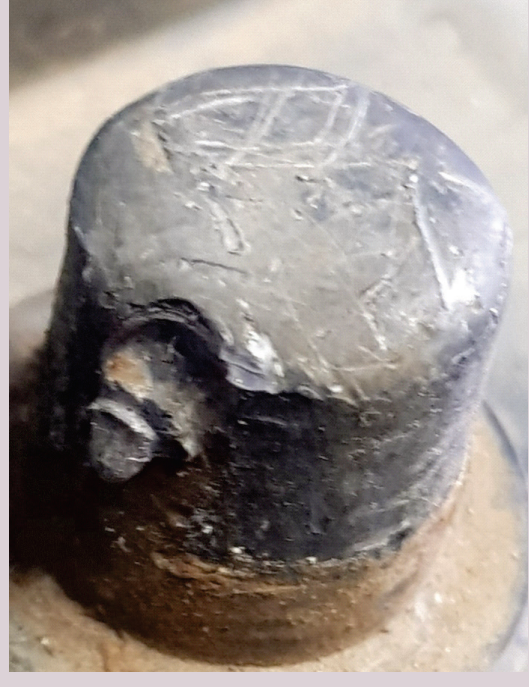
Reworked top of post. This indicate the hiding of abuse on the post and any rework marks will void the warranty

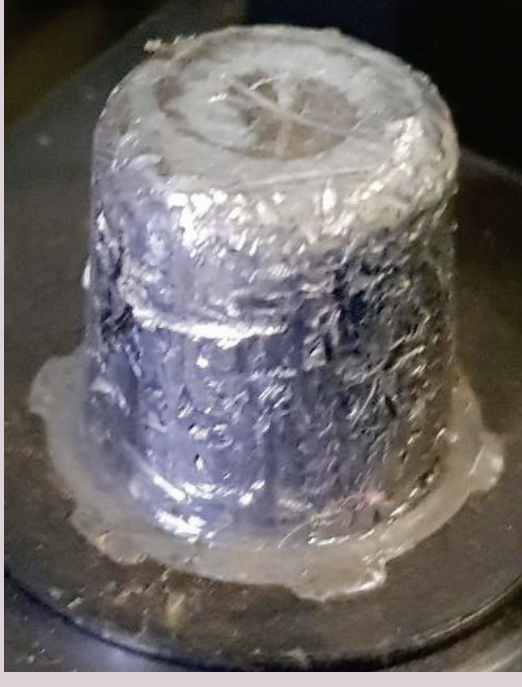
Post abuse marks. These marks indicate that the battery was not only used for automotive starting purposes as automotive battery terminals do not cause these marks under normal vehicle use

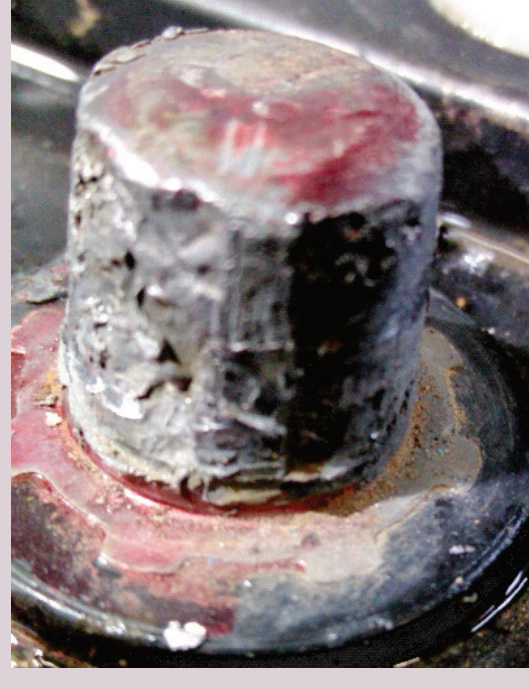
Marks on post. The marks are a clear indication that the battery was not only used for automotive starting purposes and thus voids any warranty

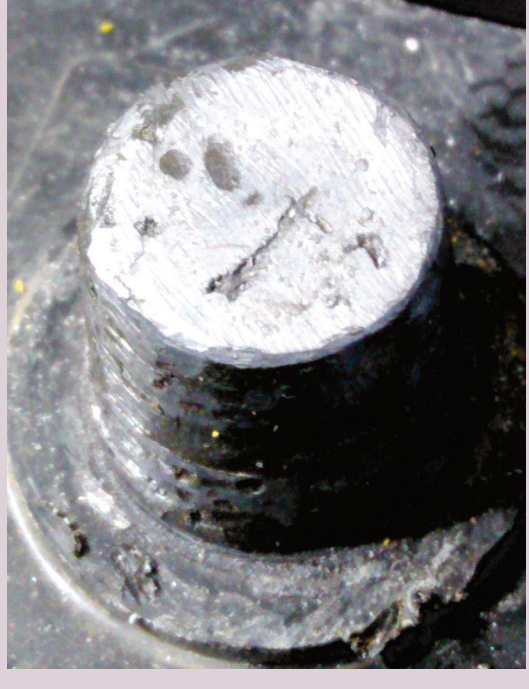
Reworked top of post. This indicate the hiding of abuse on the post and any rework marks will void the warranty

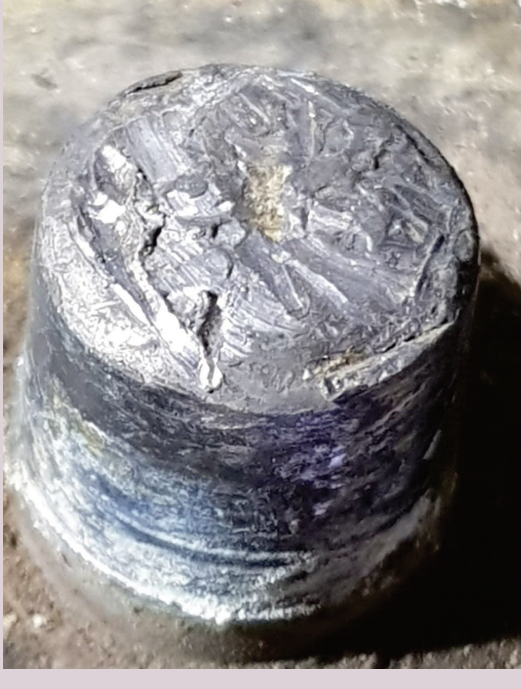
Post abuse marks. These marks indicate that the battery was not only used for automotive starting purposes as automotive battery terminals do not cause these marks under normal vehicle use
